Article

Inspection of Aircraft Wing Panels Using Unmanned Aerial Vehicles [†]

Tzitzilonis V, Malandrakis K, Zanotti Fragonara L, et al., (2019) Inspection of aircraft wing panels using unmanned aerial vehicles. *Sensors*, Volume 19, Issue 8, 2019, Article number 1824
<https://doi.org/10.3390/s19081824>

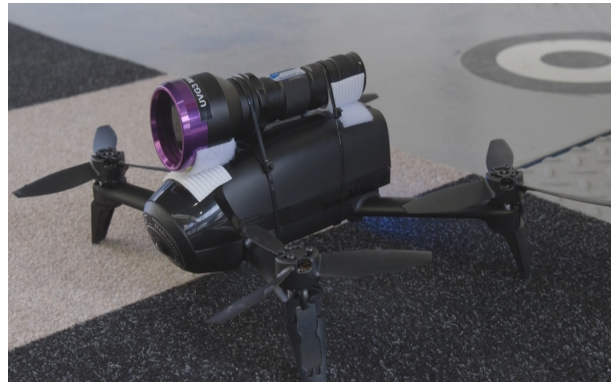
Figure 1. The aerial vehicle used in the proposed inspection methods.

Taking into consideration the aforementioned benefits of the aerial inspections, this work assesses the feasibility of using UAVs to automate the inspection of a metallic panel of an Airbus A320. Although research has been carried out on automated aerial inspection and maintenance on aircraft parts by using UAVs, no studies have been reported so far in the literature. In fact, the majority of the published papers, in this field, report the use of autonomous ground vehicles [16,17] or robotic arms for defects detection [18]. However, such autonomous systems might not be suitable for all the applications, because ground vehicles might not inspect high facilities, while robotic arms might require expensive equipment and appropriate infrastructure. In parallel, the main purpose of NDT is to check the airworthiness of a component without damaging it. In general, several NDT methods are available, including techniques such as visual inspections, borescope, liquid penetrant, eddy current, ultrasonic, acoustic emission, magnetic particle and radiography. For a comprehensive review, please refer to [19,20]. Among these NDT methods, the present study focuses on the visual and liquid penetrant inspection of metallic wing panels. In particular, is taking place prior to anodising, in order to check the wing panels for cracks and corrosion. First the penetrant is coated on to the part where capillary action pulls the penetrant in to any defect. Excess penetrant is washed off and the part is dried. Developer powder is the applied which absorbs an penetrant liquid left in the defect. Then under UV lighting the defect area is clearly visible. In this paper the automation of the final procedure of the defect recognition is proposed with the use of a small quadrotor (Figure 1), carrying a UV light, performing preprogrammed missions.

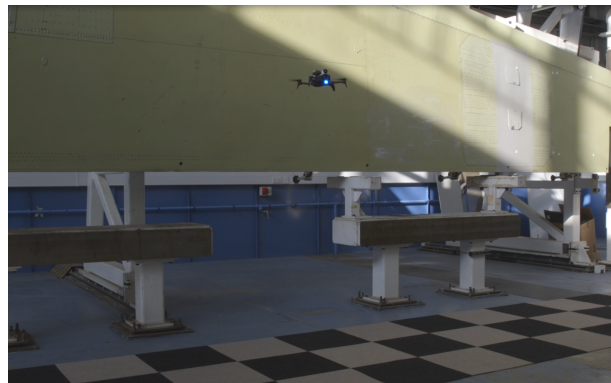
Figure 2. Aerial inspection.

In this section, an overview of the proposed UAV system is described. The setup mainly consists of the aerial vehicle, the Ground Control Station (GCS), and the wing panel for inspection. For the experiments a Bebop 2 was selected carrying a UV-light that fulfils the Airbus standard for the penetrant liquid inspection. The system can be seen in Figure 1. Detail information regarding the system can be found in [21]. For the testing a wing panel was utilised to examine the fidelity of the proposed aerial NDT methods. A 6 m long wing panel was vertically mounted to perform the visual and flow penetrant inspection methods, as shown in Figure 2.

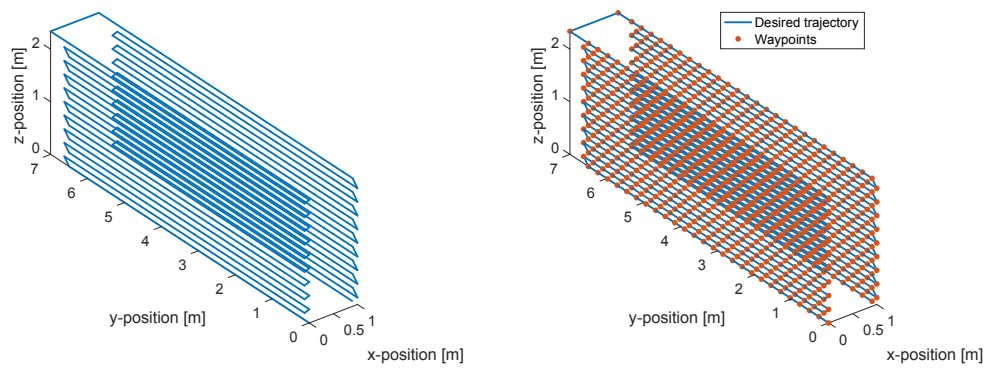
Figure 3. Desired waypoints and trajectory used for the simulations.

Figure 3 presents the waypoints and trajectory that need to be followed in the simulation of a two-sided inspection. The total inspection time for two-side wing panel was estimated at 1200 s, for a total approximately flight distance of 252 m. The velocity of the vehicle is considered constant. In the simulation model, a wing panel with 6.5 m span, 2.33 m chord, and 0.3 m thickness, is considered. The wing panel is assumed as a rectangular surface for simplifying its design complexity.

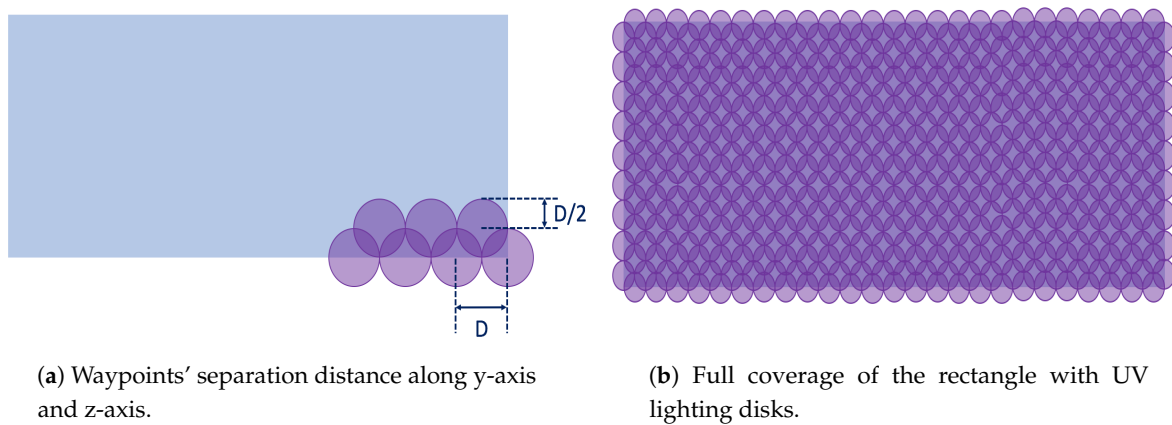
Figure 4. NDT simulated inspection.

The proposed inspection method is based on the full coverage of the rectangle with UV lighting disks, as is shown in Figure 4. The UAV keeps 1 m separation distance from the wing panel (x-axis) and hence the UV lighting diameter, which expresses the disks, is about 0.26 m. In the simulated mission, the UAV follows waypoints that have separation distance (D) 0.26 m along y-axis, 0.13 m in z-axis, as is shown in Figure 4a. An example of a wing panel that is completely covered by UV lighting disks is illustrated in Figure 4b. In this example, the number of waypoints for one-side inspection is set at 494 waypoints.

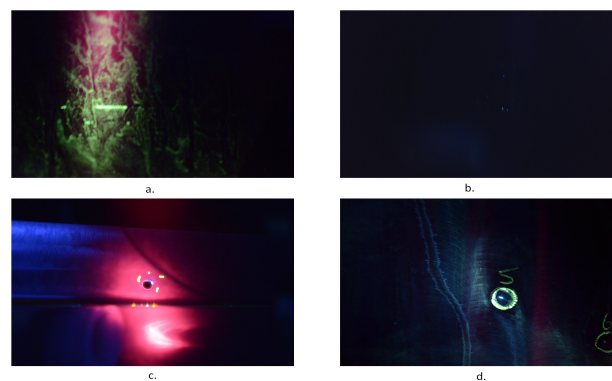
Figure 5. Images from the dataset (a) Image with green areas, (b) Image without green areas, (c,d) Images with possible defects.

The dataset which is used for validating the defect detection algorithms was created from images taken during inspection of wing panels in Airbus facilities. The photos were taken under UV light inside the black booth during an actual inspection. The equipment used was a DSLR camera of 24-megapixel and a mobile phone camera with 16-megapixel resolution. The dataset that was built has 119 images containing 25 images from 4 possible defects, images with green areas with no defects and images without any green. A representative sample can be seen in Figure 5.

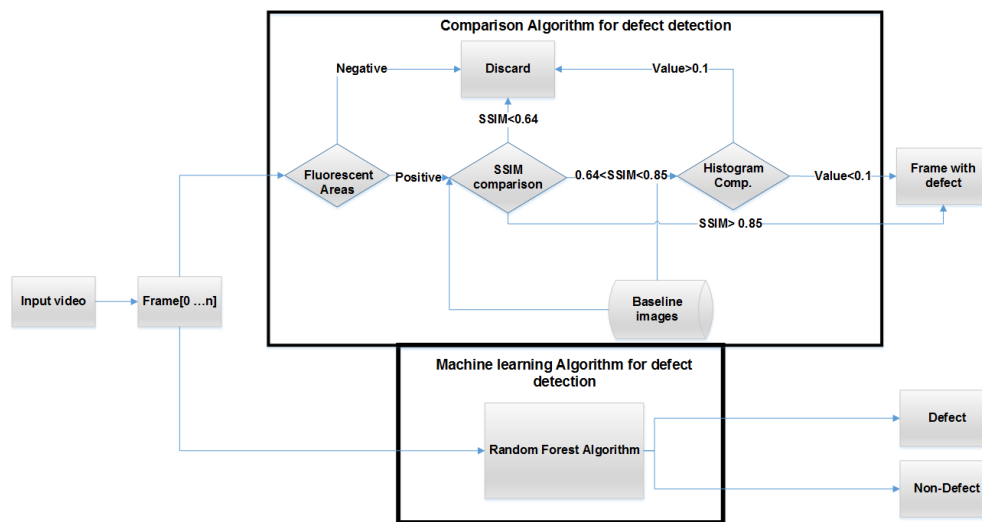
Figure 7. Flowchart of both the proposed defect recognition methods, the one with the combine use of SSIM and Histogram comparison and the Random Forest.

Some of the challenges that the algorithms had to address was the conditions of lighting and how to distinguish the fluoresce areas with defects with the ones without defect. During the inspection most of the areas that luminance under UV light with green do not contain any defect. To address the problem, two different approaches were implemented and tested. In the first one, images with defects were compared with image data from inspection and their similarity was calculated by combining two different image processing algorithms. In the second, a Random-Forest algorithm was implemented for classifying the images in defect or not categories. The results of both methods were compared. In Figure 7 the flowchart of the proposed methods can be seen.

In the first method, the software initially filters the images keeping only the ones that contain green areas. Then it uses two different algorithms, Structural Similarity Index Measure [22] and Histogram Comparison, to classify if these images contain any possible defects. In a step by step description of Figure 7 the algorithm first discards any images that do not contain any green area. Then the remaining images are compared with the baseline images using the Structural Similarity index Measure (SSIM) [22]. The outcome of this comparison can be either positive (defect was found), negative (no defect) or further investigation is needed. The outcome depends on the different values of the SSIM. If further investigation is needed a histogram comparison with the baseline images is taking place. In the second method the images are fed to a Random Forest Classifier. Detail description of both methods is given in the rest of the section.

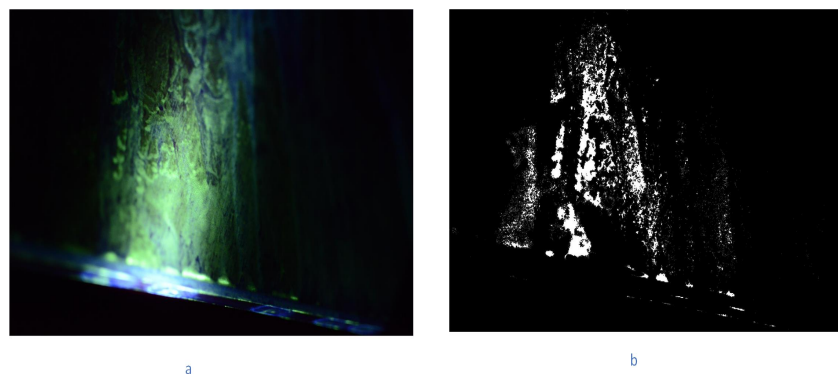
Figure 8. (a) Initial Image containing green areas, (b) Image after masking.

For this reason, a mask was implemented. The mask covers all the pixels that do not have value in the range of green in the RGB and colours with white the green ones (Figure 8).

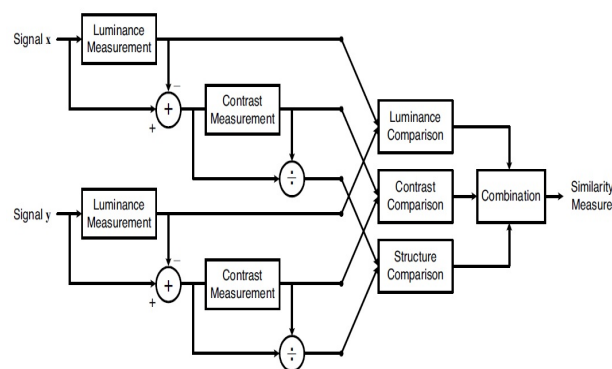
Figure 9. Diagram of the structural similarity (SSIM) measurement system.

Then the algorithm finds the contours in the images. Contours can be explained as the closed curve joining all the points delimiting an area with the same colour or intensity. If the image contains at least one contour meaning that then definitely has some green colour. After filtering, the remaining images containing green areas are compared with the baseline images that were taken at Airbus facilities. For the comparison, the algorithm of SSIM was used. SSIM is an index used for measuring the similarity of two images. It can be seen as a quality measure of the image that is being compared and it takes values between -1 and 1 . If the compared image is completely different from the initial the value will be -1 while if they are identical/very similar it will be 1 . The comparison is made by measuring luminance, contrast and structure. Image Structure is an arrangement and organization of interrelated elements in an image. The structural diagram of the algorithm is presented in Figure 9.

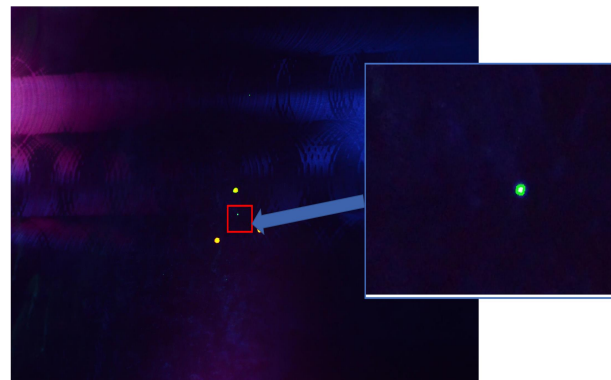
Figure 11. Image with possible defect.

In Figures 11 and 12 two images with possible defects can be seen. Image in Figure 11 is one of the 25 images containing possible defect and in Figure 10 is an image without any defect but contains green spots. The images are very similar so the software has classified it as a possible defect. This is due to the limited amount of images containing defects but as more images will be added to the dataset the performance of system will be improved.

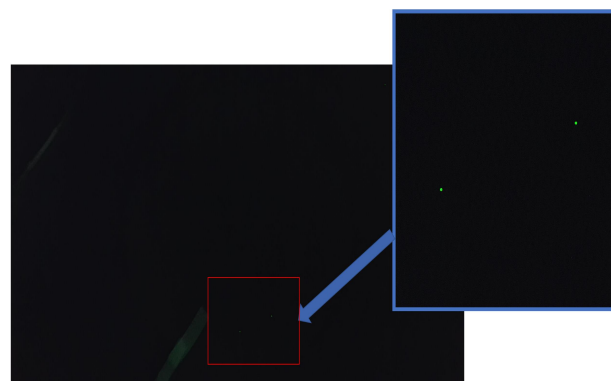
Figure 12. Image with false positive defect.

Results show that both defect methods are performing very well in identifying defects. It is worth noticing that the image in Figure 12 that was classified as false positive in the combined SSIM and Histogram method, with Random Forest was classified correct, labelled image H in Figure 13. The comparison method is performs well but the computational time needed for running the whole dataset was 3 min in Intel Xeon 2.66 GHz processor, so as the dataset will get larger it will be even slower as more comparisons will be needed to be performed. On the other hand, testing and validation results of Random Forests are promising and indicate that this approach is able to detect defects even with this small dataset. In addition, the Random Forest algorithm performs faster than the comparison method. The random forest algorithm classified the 10 random images in 5 s which is significantly less than the comparison method which needs 15 s for the same number of images. Though it is not possible to extract solid conclusions in such a small dataset, the machine learning method has an advantage, as once properly trained will be able to generalize better on the data rather and will also will be faster than the comparison method.

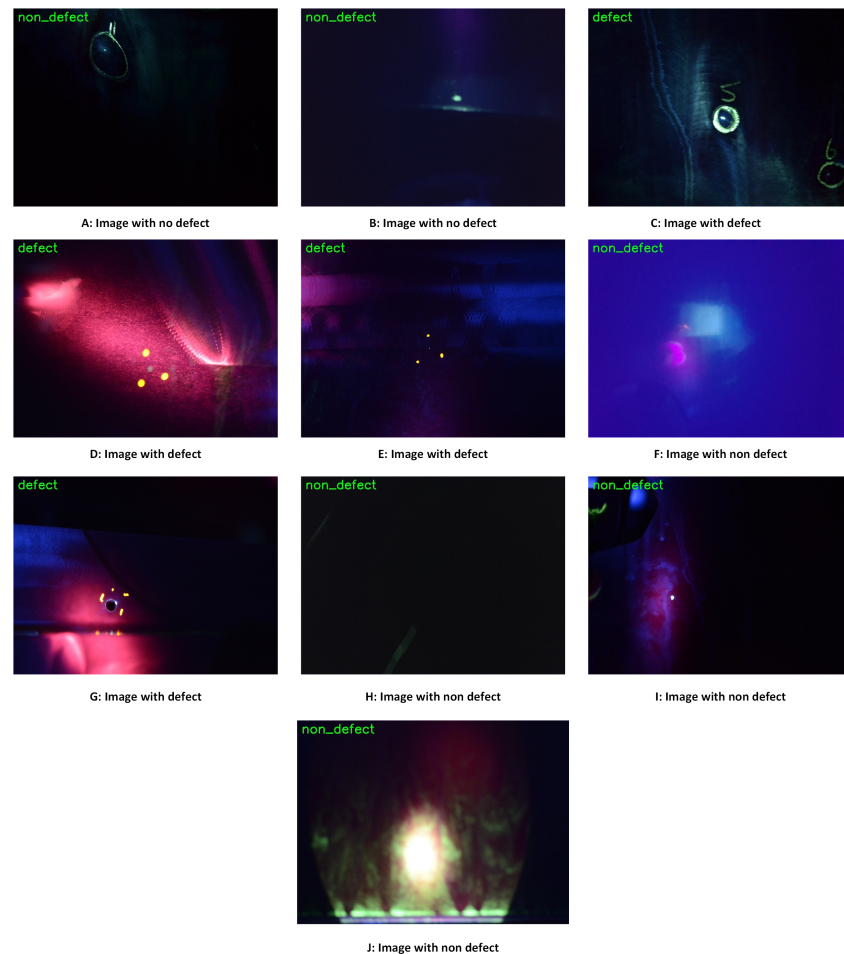
Figure 13. Results of the Random Forest algorithm. (A–J) titles are the class were the image actually belongs and the green title on the image is the outcome of the Random Forest algorithm.

The model was tested also in 10 randomly selected images from the dataset. The accuracy of prediction was 100% and the results can be seen in Figure 13.
